Jersey Meadow Golf Course Clubhouse

Assessment Report

City of Jersey Village
16327 Lakeview Dr.
Jersey Village, Texas 77040

Ray+Hollington Architects, Inc.
5218B Blossom St
Houston, TX 77027
713.524.6131

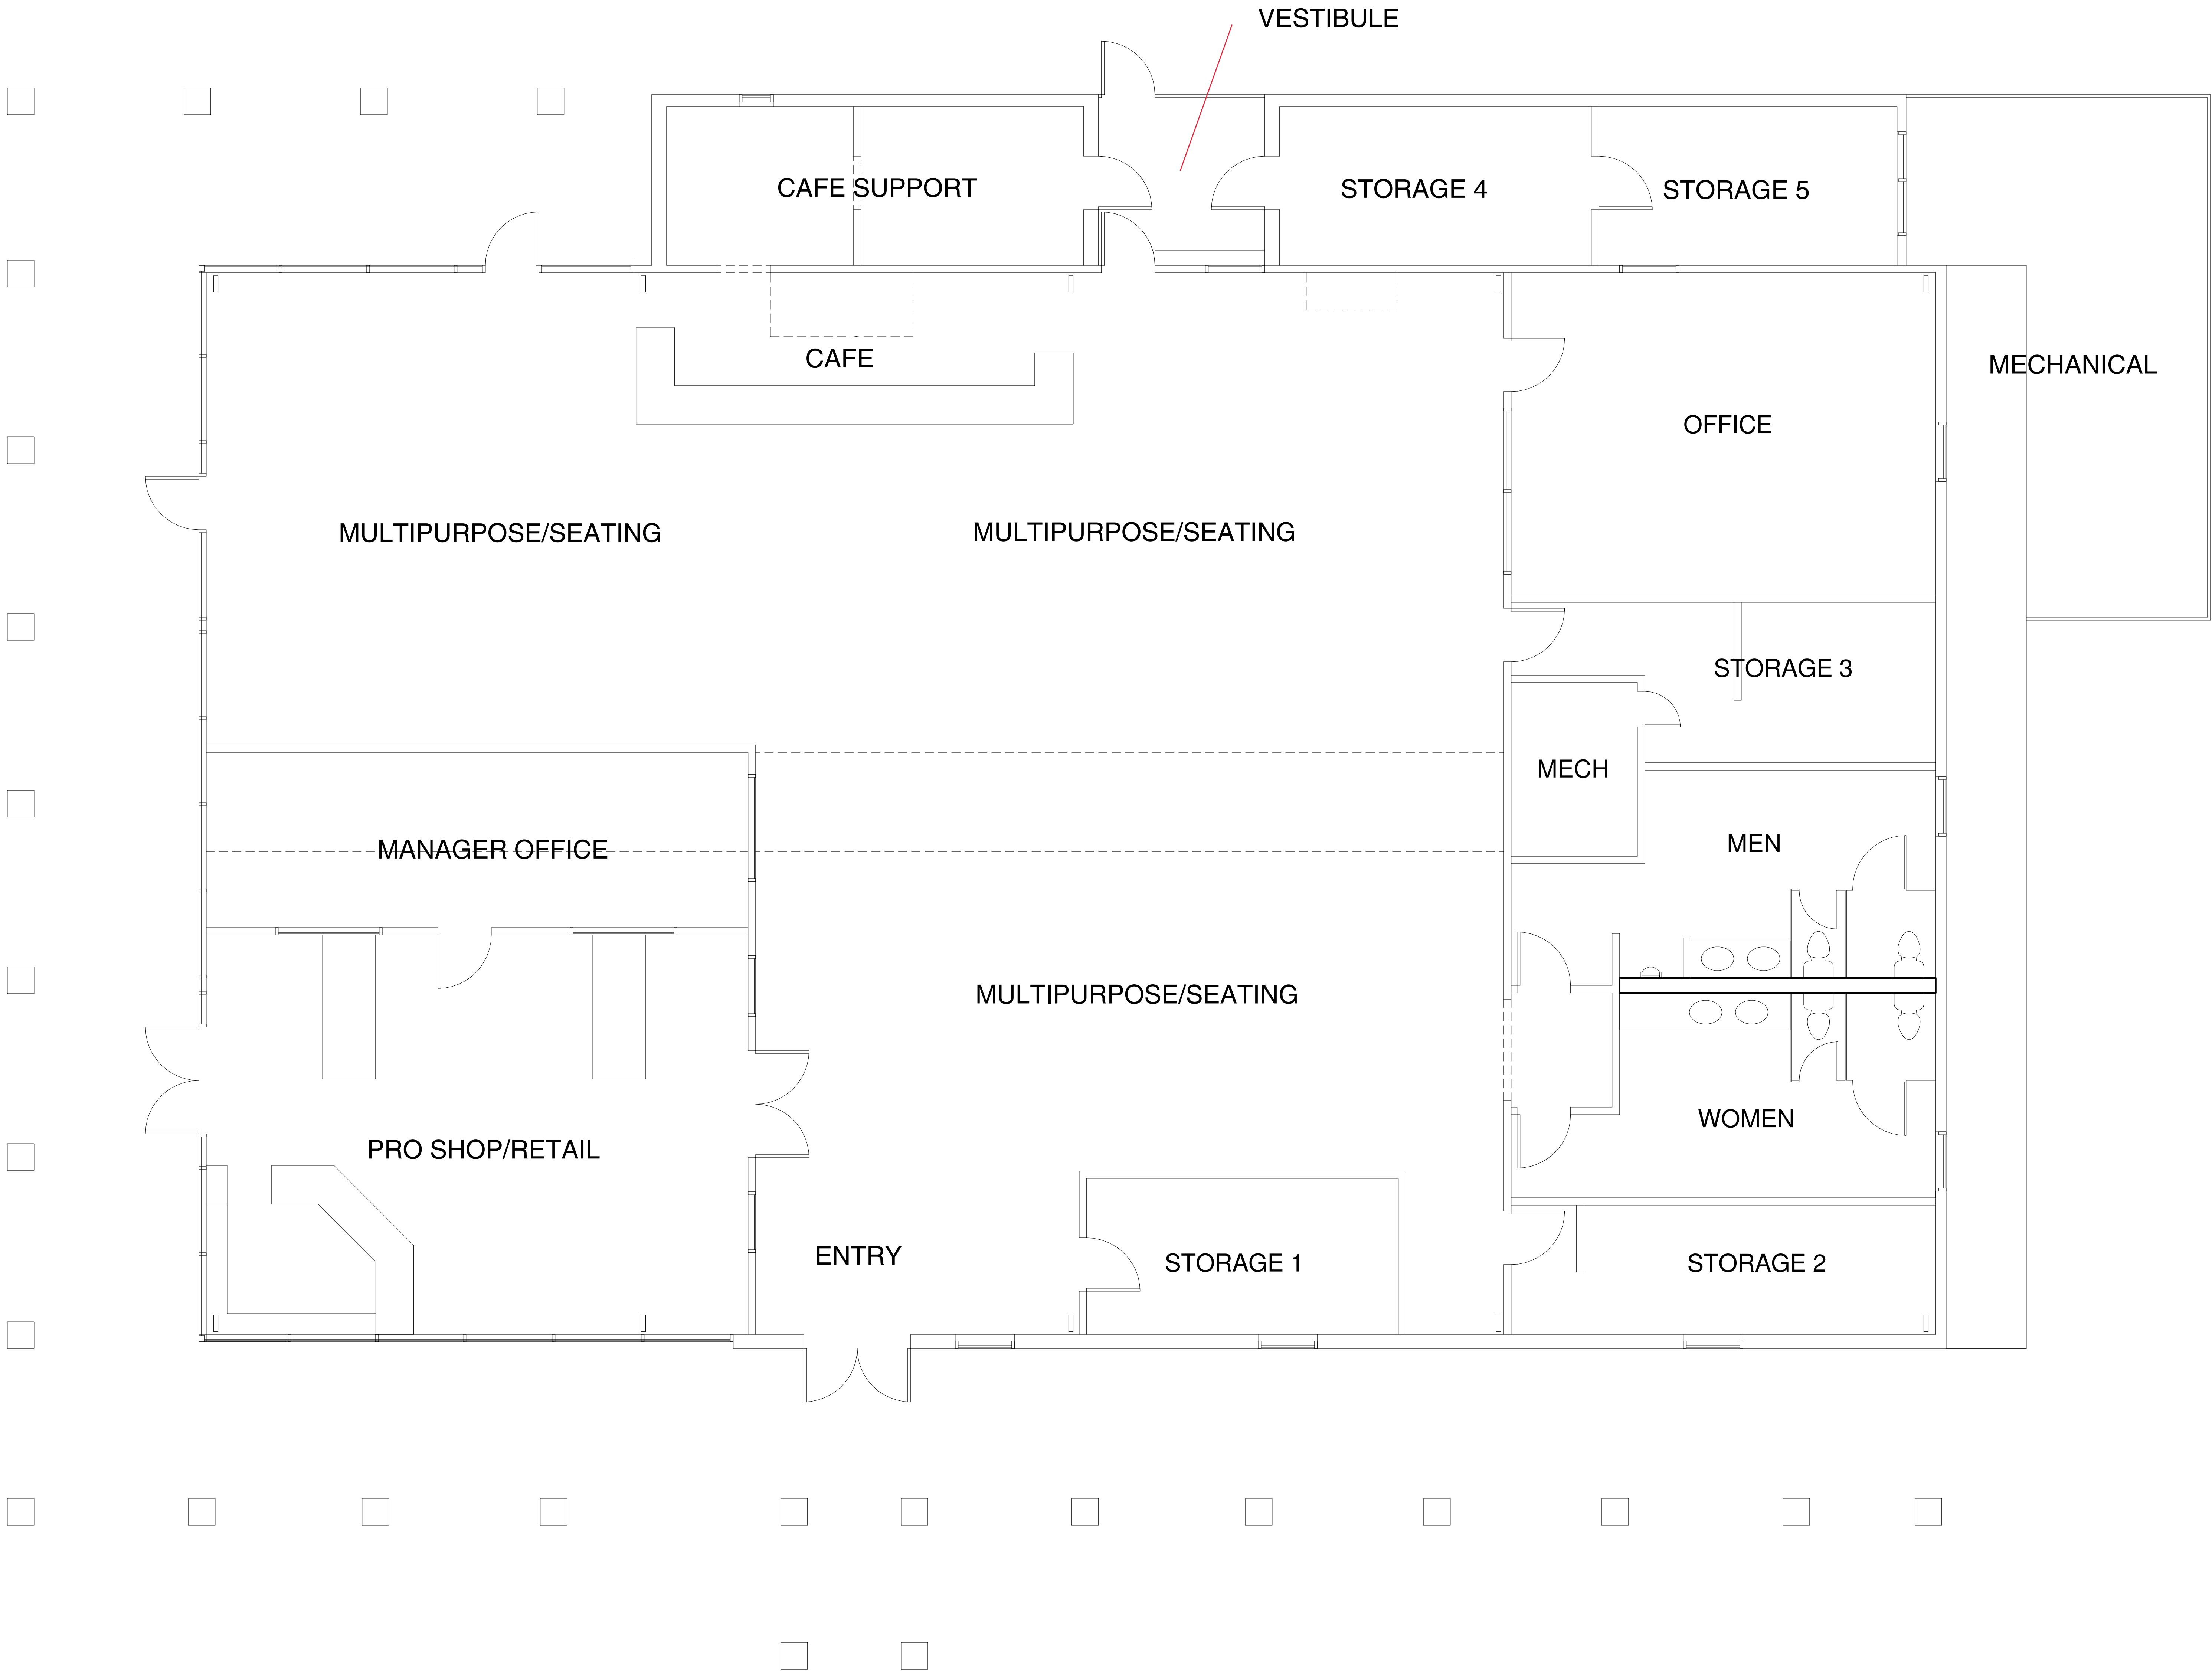
A100

-
- POOR LIGHTING / CONTROLS
- SINGLE GLAZING IN NON-THERMALLY IMPROVED FRAME
- WINDOW HEAD DETACHED
- WINDOW UNIT
- SEAL DOORS
- STORAGE 4
- STORAGE 5
- HWH
- LEAKS @ ROOF JUNCTION
- CAFE SUPPORT
- FOOD PREP
- CAFE
- BAR
- A/C UNIT
- NO ADA ACCESS
- MULTIPURPOSE/SEATING
- OFFICE
- I/T EQUIP
- STORAGE 3
- MECH
- A/C UNIT TO BE REPLACED
- PROVIDE PRIVATE OFFICE
- HVAC DUCT ENCLOSURE
- MANAGER OFFICE
- INADEQUATE A/C
- REDESIGN COUNTER
- PRO SHOP/RETAIL
- ENTRY
- STORAGE 1
- NO A/C
- STORAGE 2
- STORAGE 3
- MEN
- WOMEN
- MECHANICAL
- EXTERIOR GRA FINISH FLOOR
- NEED ADA THRESHOLD
- WINDOW UNIT

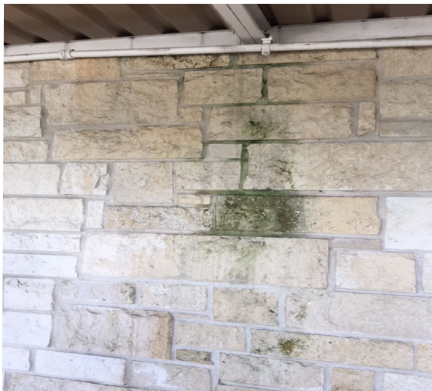
CANOPY: The canopy system appears to be structurally sound and in reasonably good condition. The columns were clad in masonry to match the building facades and cannot be evaluated. Flashing at the head of the canopy and other junctions has failed allowing leaks.

Canopy Leak

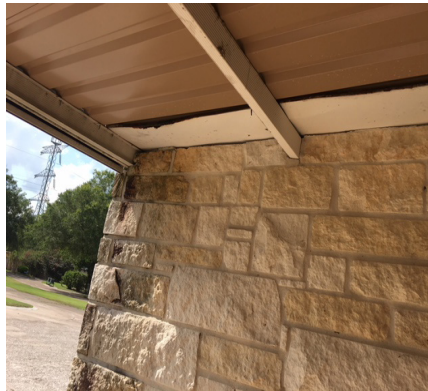
Canopy Leak

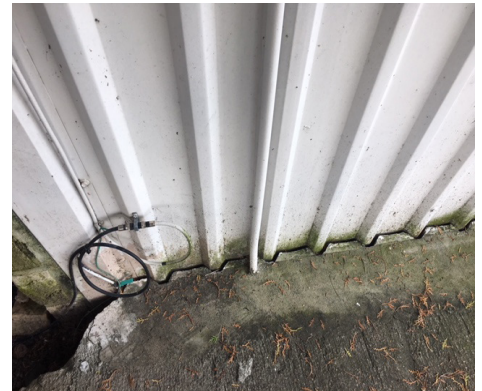
The north façade did not receive the masonry veneer. On this elevation, the metal panels and trim have deteriorated badly and are in poor condition. Concrete paving has been placed directly against the base of the panels, raising the exterior finish elevation above the level of the interior floor. This condition is of major concern since the exterior grade slopes toward the building, creating ponding against the building and consequently water penetration along the wall.

Sidewalk poured against north wall

- A. Replace the metal roof and north wall panels.
- B. Install vapor barrier and thermal insulation at exterior walls and roof.
- C. Verify condition of exterior wall framing and roof framing.
- D. Replace existing storefront glazing with thermally improved framing with insulating glass units.
- E. Correct grading and drainage issues north of the building.

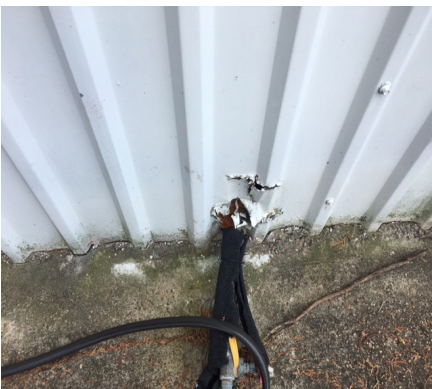
Service entry at north wall

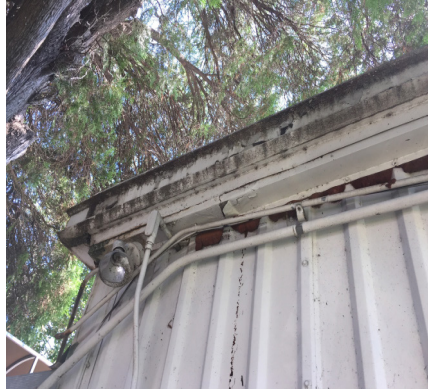
Northeast trim fascia

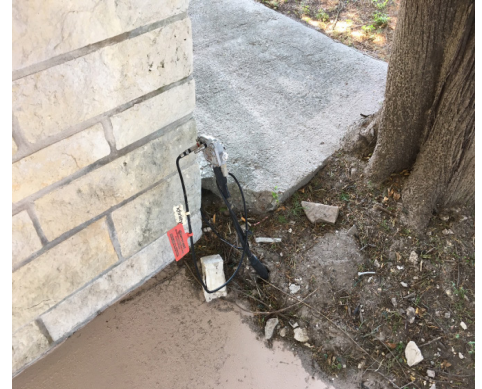
Sidewalk at northeast corner

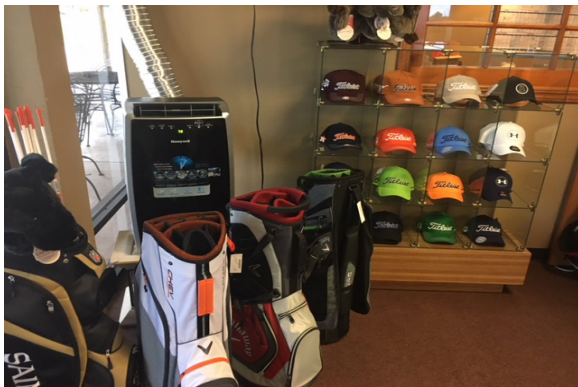
Supplemental AC Unit

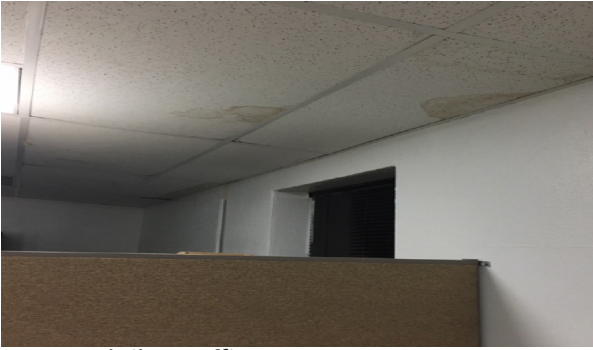
Damaged tile at office

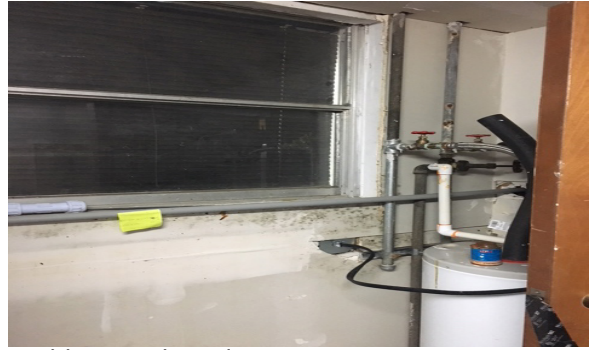
Mold at Gyp board

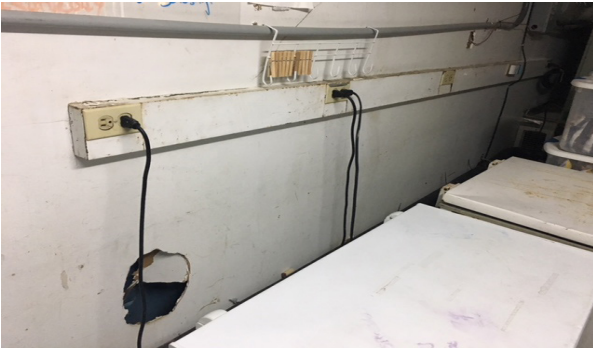
Wall penetration

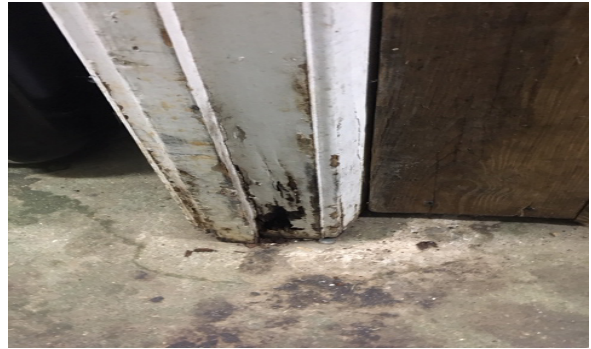
Water damage

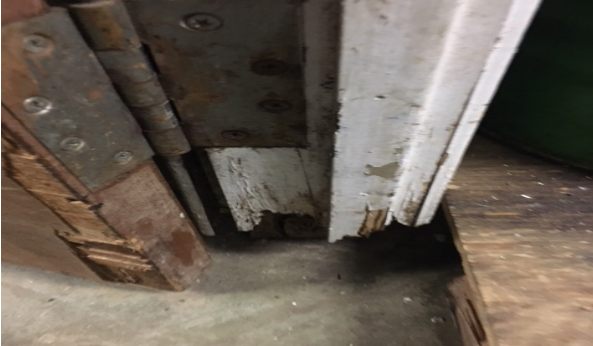
Water Damage

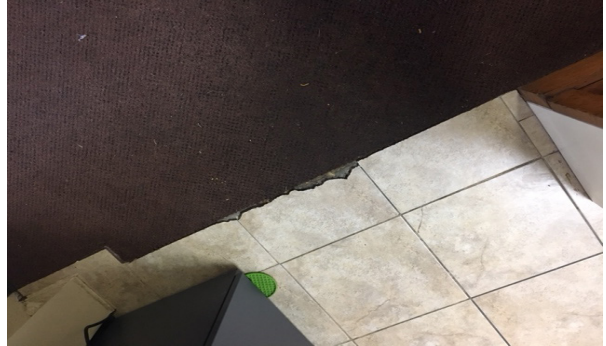
Broken tile edge

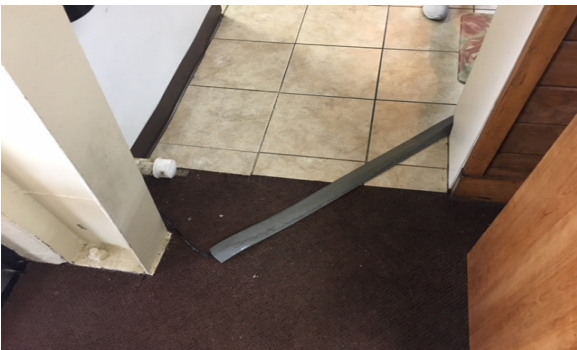
Wire at floor

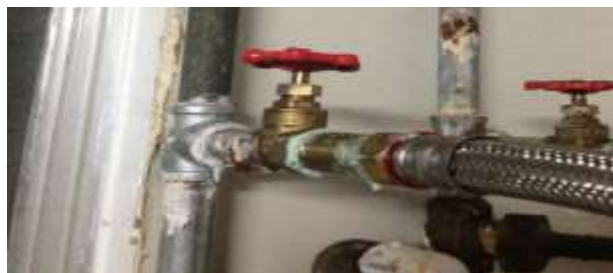
Galvanized Piping to and from Water Heater

Concerns: The galvanized piping is showing major signs of corrosion especially at the threaded fittings and valves which were not properly re-galvanized after being treaded.

1. In the near future the domestic water galvanized piping system will have to be replaced. For the above ground piping we would recommend a budget of \$25,000 for this piping replacement to the restrooms and Café not including any sheetrock walls that would need to be accessed especially in the restrooms. Half of this budget cost is for the piping to the restrooms and café. The other half is for the building exterior hose bibbs whose service connection points are assumed to be difficult to access.

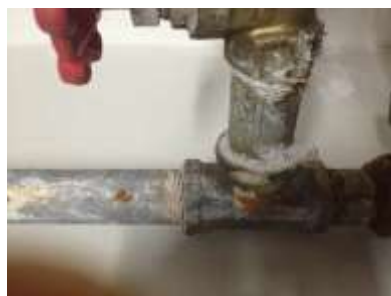
Corrosion at valves and fittings

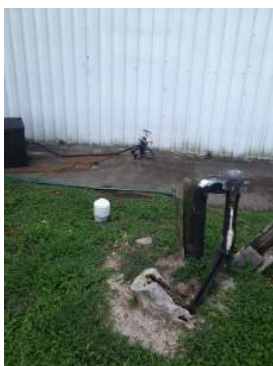
4" PVC Sanitary Sewer Cleanout

Concerns: If the building is to have substantial renovations a greasy waste sanitary system including a grease trap would be required to be provided by current code.

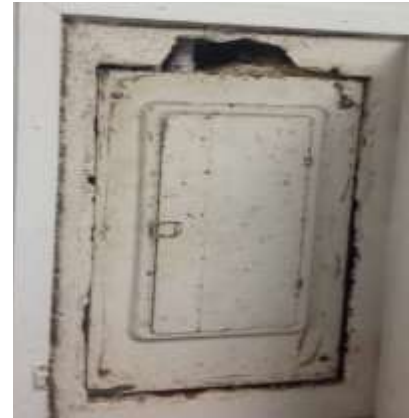
Primary 100 amp 120/240 Panel in
office

Concerns: The primary electrical distribution panel in the management office is in very poor condition.

1. Primary 100 amp. electrical panel in the office should be replaced. Budget Cost \$5,000

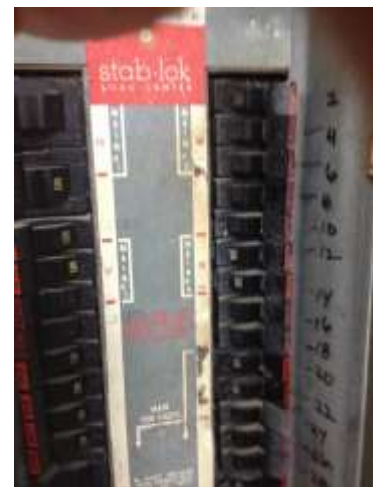
Primary Elec Panel

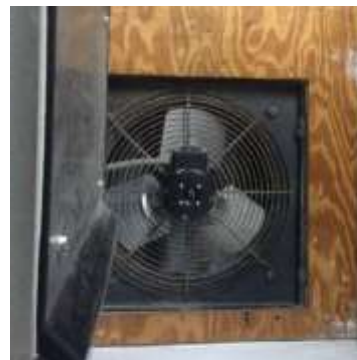
Assumed Outside Air Fan Not Operational
