Jersey Meadow Golf Course Clubhouse

Assessment Report

City of Jersey Village
16327 Lakeview Dr.
Jersey Village, Texas 77040

Ray+Hollington Architects, Inc.
5218B Blossom St
Houston, TX 77027
713.524.6131

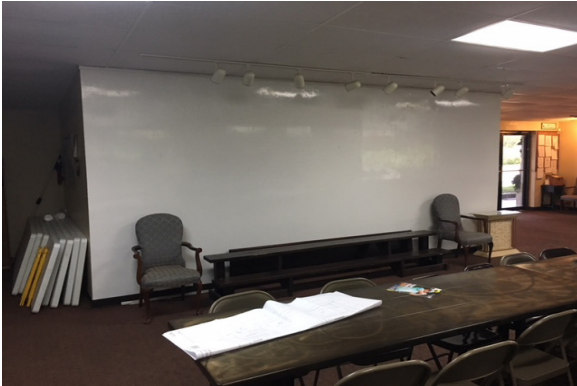
MARKER WALL

The meeting areas seem dark and poorly lighted. The two seating areas are isolated from each other by the pro shop offices located in the southeast corner of the building. The space is of adequate area to accommodate the desired capacity but is poorly configured. The existing carpet needs replacement and upgrading. The large duct enclosure at the center of the room is a major disruption in the space. The larger seating area has no natural light. The space is of adequate area to accommodate the desired capacity but is poorly configured.

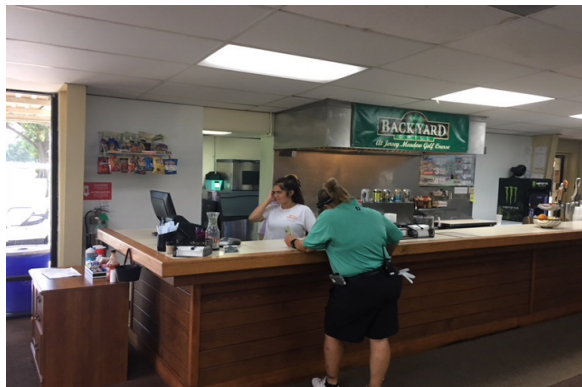
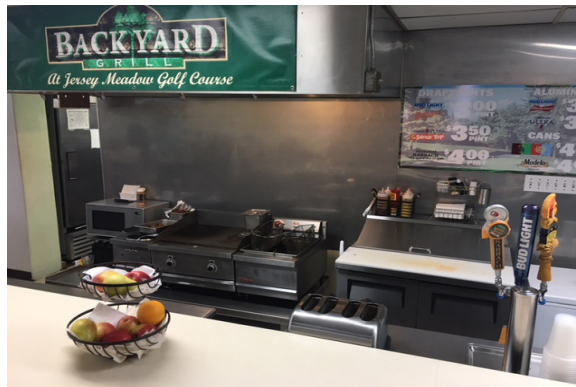
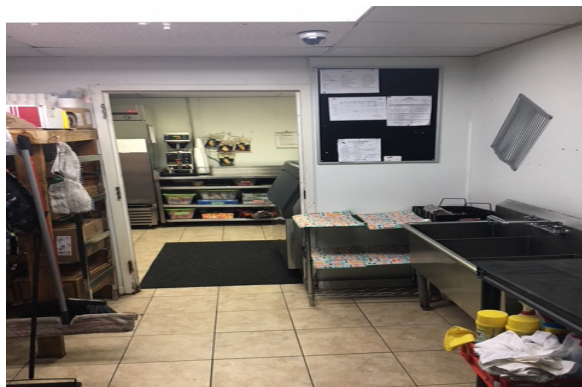
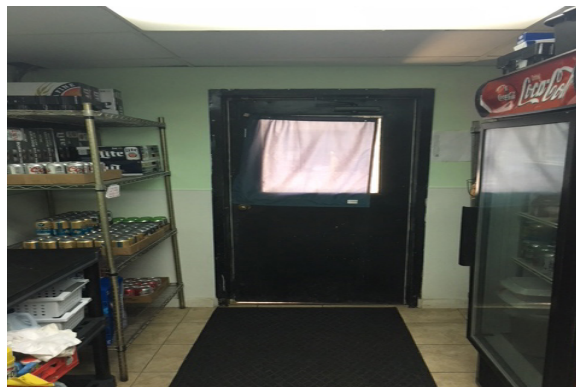
The bar/service area is rather plain and appears dated. In its current figuration it does not provide required accessibility. Food prep is an open grille behind the bar with a large hood and stainless steel back wall. Other finishes are painted Gyp board with minimal decoration or display.

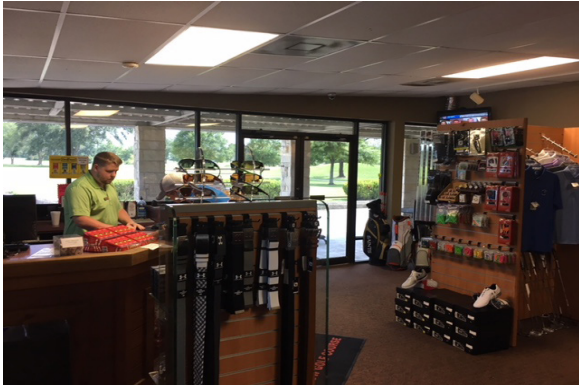
The pro shop is cluttered and overfull with limited wall space for display. There is a desire to reconsider the design and layout of the sales counter. Air conditioning is inadequate or nonexistent, a condition exacerbated by the extensive single glazing.

Sales Counter

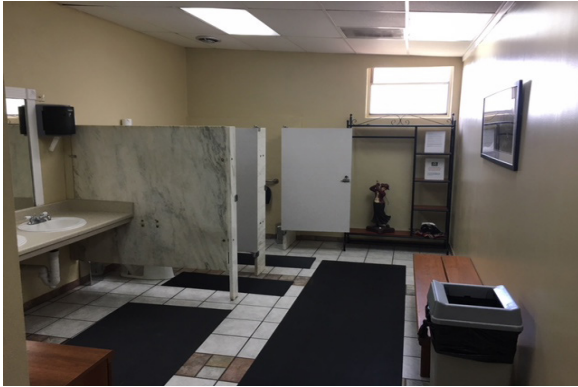
Locker room/toilets comply with accessibility standards but are of a low standard of finish (with the exception of the marble toilet partitions). There are no locker or changing facilities and the quantity of fixtures in the men's locker room/toilet is considered inadequate.

Toilet Rooms

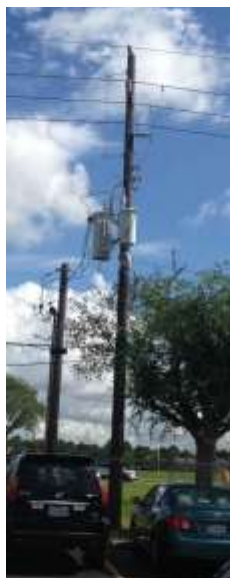
Pole Mount
Transformer

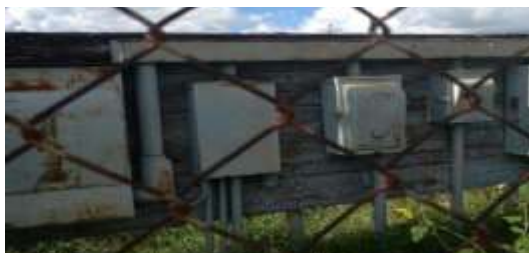
Closeup of Disconnects

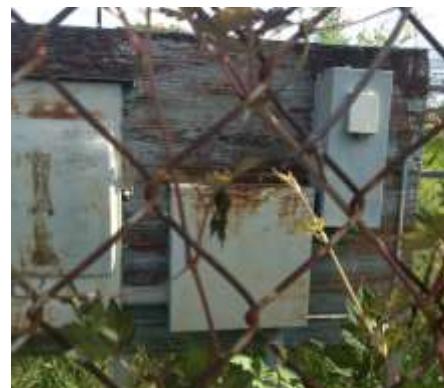
Closeup of Disconnects

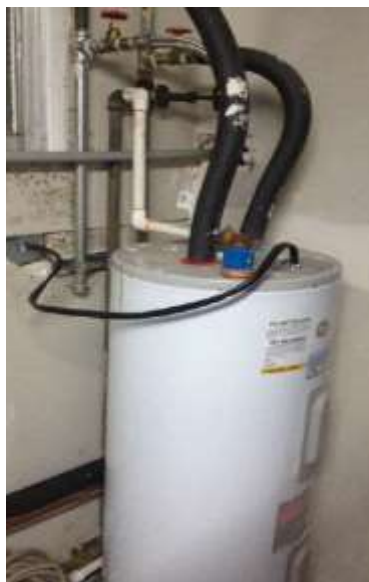
Electric Water Heater

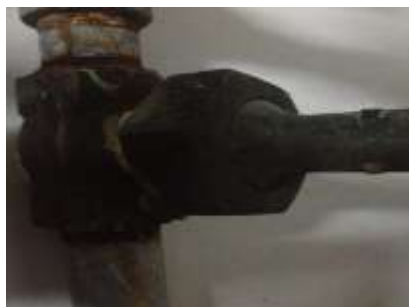
Main Water Shut off Valve

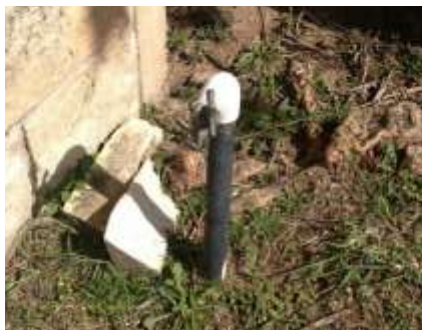
Exterior Hose Bibb

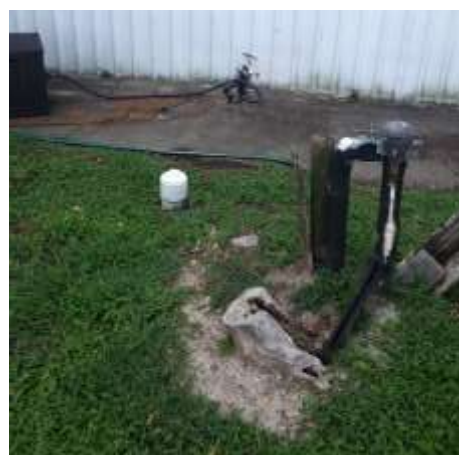
Exterior Hose Bibb, Sanitary Clean Out, Landscape Backflow Preventer

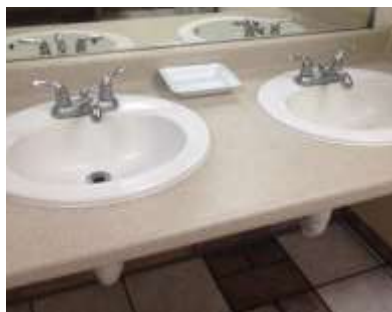
Lavatories

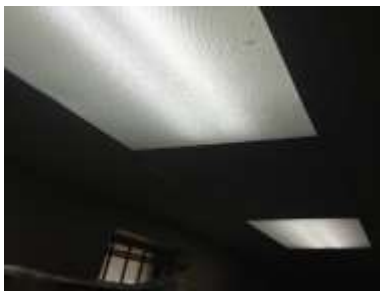
Survey: The lighting for this facility is mostly 2' x 4' lay-in fluorescent fixtures with T-12 bulb/ballasts. Some of the fixtures are single ballast, some dual ballast, some (2) bulb and some (4) bulb. There is no observed zone or dual switching capability.

TYP Fixture 4-Bulb w/ 2-Bulb I

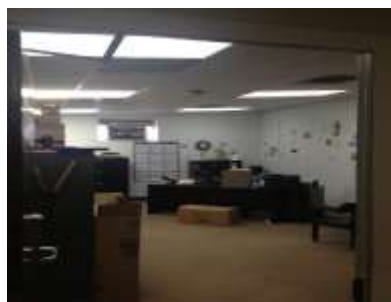
Office Lighting

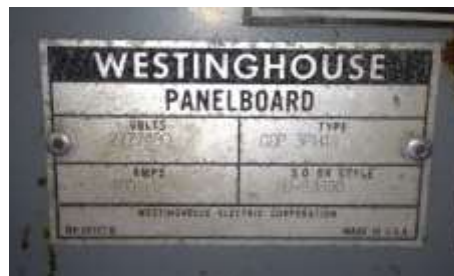
Main Disconnect 400 amp 277/480

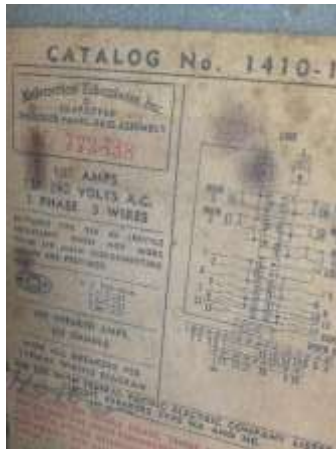
Primary Elec Panel 100 amps

Concerns: The primary electrical distribution panel in the management office is in very poor condition.

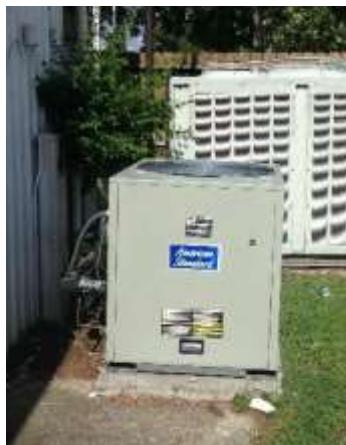
It appears that when condenser unit #1 was replaced AHU #1 was still in acceptable shape, but to possibly address the facilities cooling issue's the existing 20 ton condenser unit was replaced with a New 25 ton unit. A 25 ton condenser unit serving a 20 ton AHU does not result in the delivery of an additional 5 tons of capacity. The supply duct and side wall grilles down the center of the multi-purpose room provides very poor coverage for the facility. The supply air throws across the east side of the multi-purpose room and far south end of the Café seating area especially against the glass wall, is too far and no means of balancing the air were observed. Additionally, none of the storage rooms have supply air grilles. The ductwork serving the woman's restroom is restricted directly above the restroom vestibule which has resulted in little to no supply air to this restroom. There is an 18" flex duct tapped off the top of AHU #1's discharge plenum that is run west some 20' that may have been an outside air duct, but it is not connected to any exterior louver and should have been connected to the return plenum if it was for outside air, so as it is now it is just delivering conditioned air to above the ceiling of the office area? There is no outside air observed for either AHU #1 or #2 Systems. A/C System #2 appears to have been added as part of the addition of the Café, but appears to be undersized to handle the shortfall in the main facilities load and the added loads of the Café equipment, hood and storage areas. There is a control system box on the wall next to AHU #1 but it does not appear to be operational. Both systems appear to be operated via simple thermostats located near the return air filter grilles.

A/C Condenser Unit #2 in front w/
#1 behind

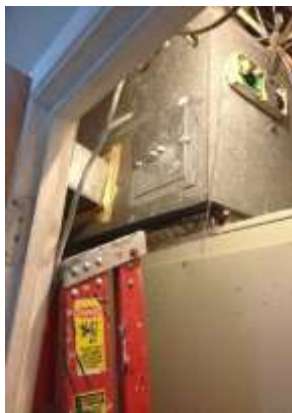
AHU #1

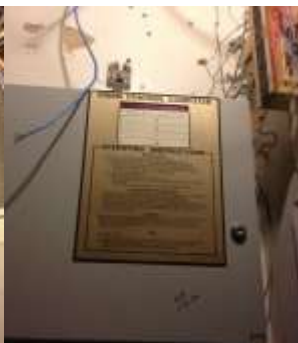
Control System in Room
w/ AHU #1

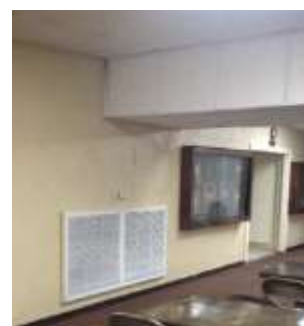
Return Grille AHU #1

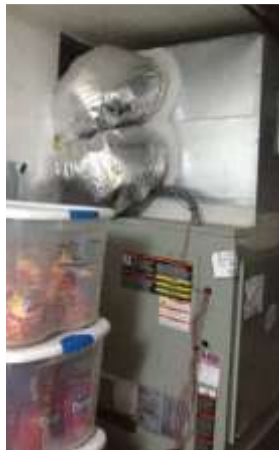
AHU #2

Concerns: The lack of outside air being ducted to the AHU's results in the systems making up for the exhaust from the Café and restrooms being brought into the facility as raw outside air via the doors and cracks creating hot/cold spots as well as humidity issues.

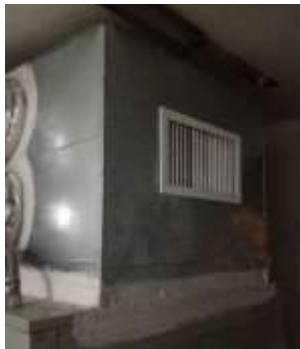
AHU #2 Grille in Storage

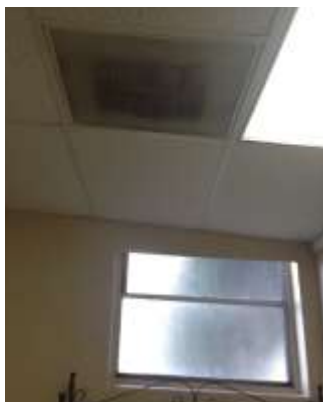
Women's Restroom Supply Grille

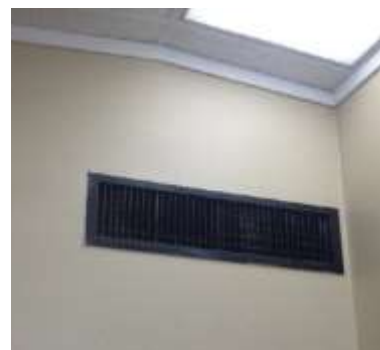
Men's Restroom Supply Grille

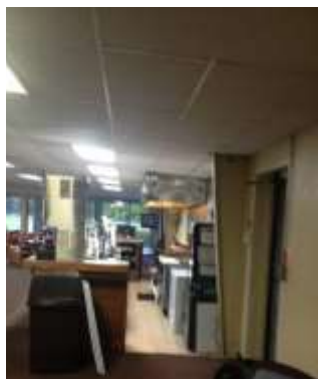
Café Hood

Concerns: The hood Ansul system cylinder capacity should be checked to ensure that it's remote location was taken into consideration when it was sized/installed. A much better location would have been in the storage room directly behind the Café cook line. Capacity of the hood for the cook top it serves—as well as the size of the exhaust fan and make-up air fan and their condition—should be checked.

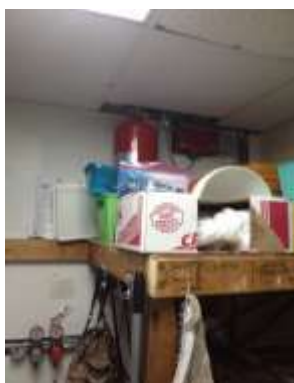
Café Hood – Fire Suppression System

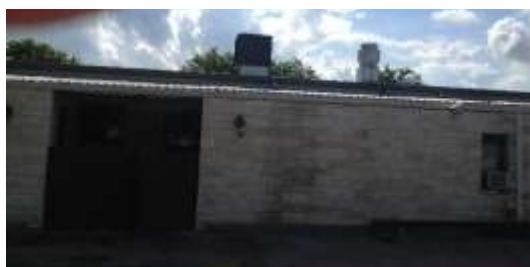
Café Exhaust & Make-Up Air Fans

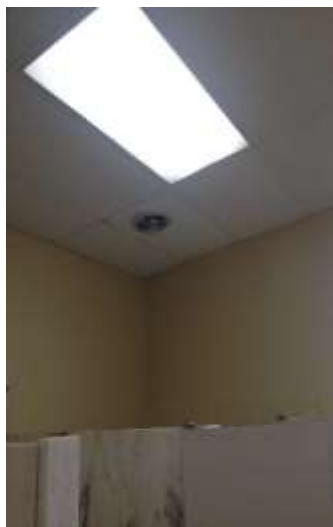
Men's Restroom Exhaust

Concerns: Current code does not allow for restroom exhaust to be discharged into the ceiling plenum for a non-residential facility.

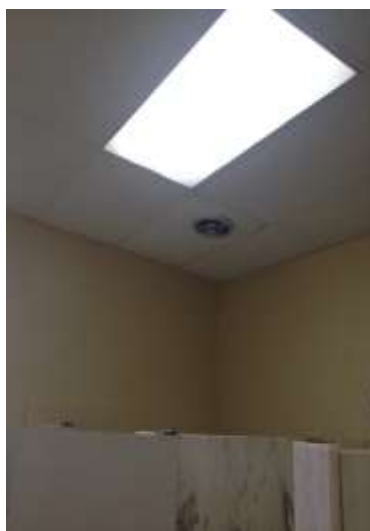
Women's Restroom Exhaust

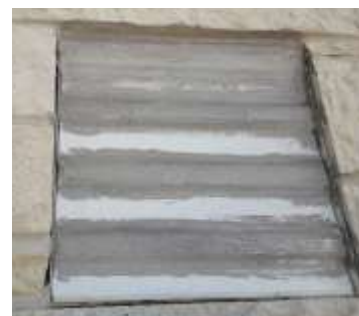
Survey: Each restroom has a small ceiling exhaust grille which is assumed to have a small exhaust fan above the ceiling. There are no exterior exhaust grilles/louvers observed for these fans. In the storage room where AHU#2 is located there is a wall exhaust fan which has been blanked off on the exterior and is not currently operational.

Blank Off of OSA Fan

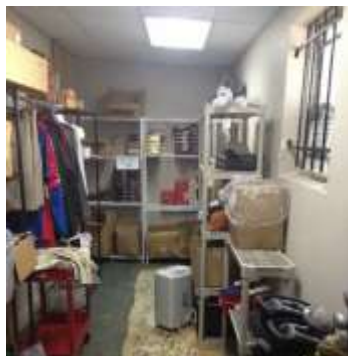
Dehumidifier

Concerns: These miscellaneous fans, dehumidifier, and free-standing A/C units only provide limited spot comfort (air movement) and are not really effecting the underlying issues.

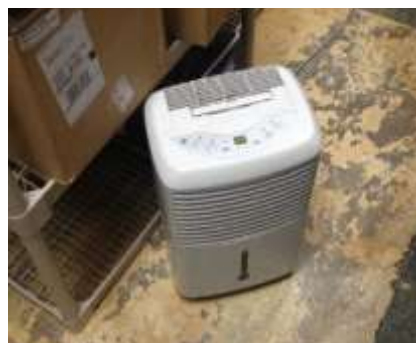
Dehumidifier in front storage room

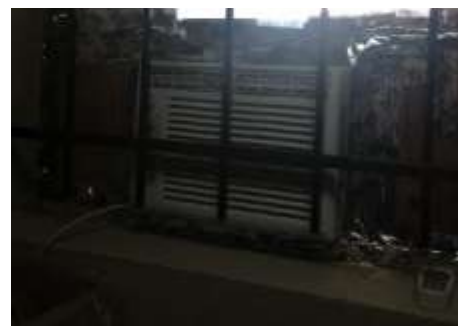
Window A/C

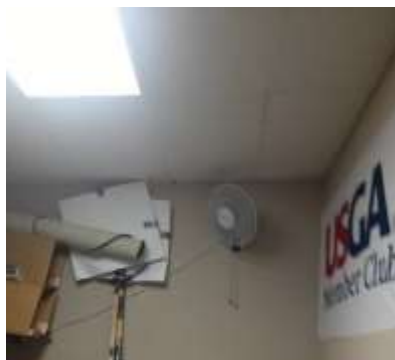
Fan in Storage Room

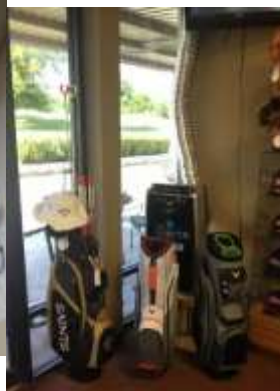
Free Standing A/C
Unit in Pro-Shop

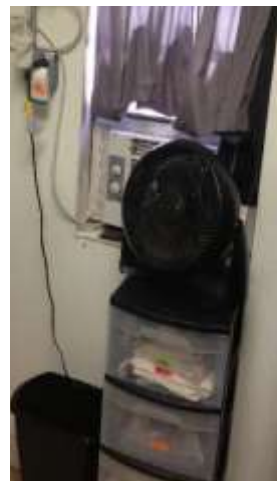
Fan & Window Unit in Room
Behind Cafe

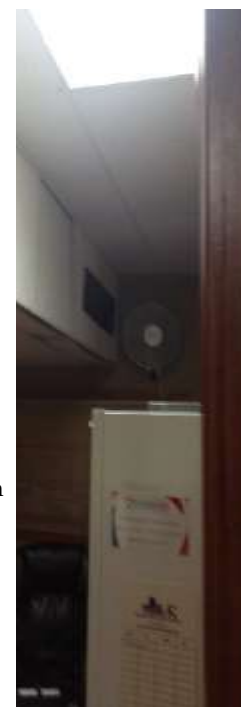
Fan in Pro-Shop Office
